MONITORING GULLY FORMATION AND DEVELOPMENT FOR EFFECTIVE REMEDATION AND CONTROL

Jacob Odeh EHIOROBO & Osadolor Christopher IZINYON

University of Benin

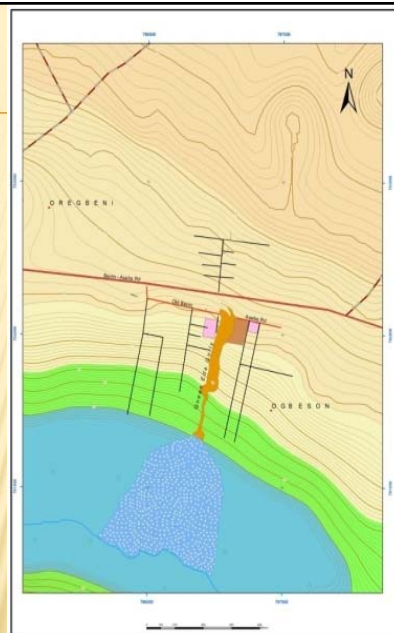
QUEEN EDE GULLY CATCHMENT AREA

The gully area is bounded by UTM coordinates 700800mN to 702500mN and 795800mE to 79600mE. The gully runs in a south – easternly direction down to Ikpoba river. The elevation of the study area ranges from 16m to 110m above sea level (fig1). The average temperature in this area is 28^oc. The raining season commences usually from April to October with a break during the month of August, commonly referred to as August break. Maximum recorded rainfall 2001–2011 was 439mm with a minimum of 3.75mm. There is however a sharp deviation this year 2012, probably as a result of climate change, as heavy rains have been experienced from January to date. Humidity is generally high about 98% for most of the year. The area lies within the tropical rain forest zone of Nigeria

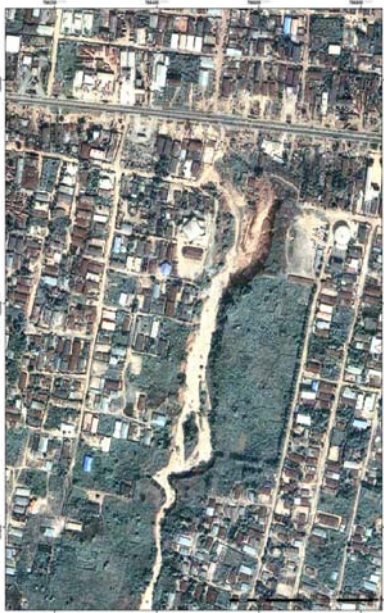
Fig 3: Ikonos Imagery of Queen Ede Gully Site

The total station measurements in each epoch were collected at centimeter level resolution to capture break in slope and other topographic features necessary for producing accurate Digital Elevation Model (DEM). The gully cross sections along with topographical profile of the gully bed from head to outlet was carried out using Automatic level with Telescopic staff. Ikonos imagery was acquired to measure and monitor the extent of the eroded area as well as providing a quantifiable estimate of the landed area and in the analysis of physical structures that have been affected or endangered by the gully (See Fig 3).

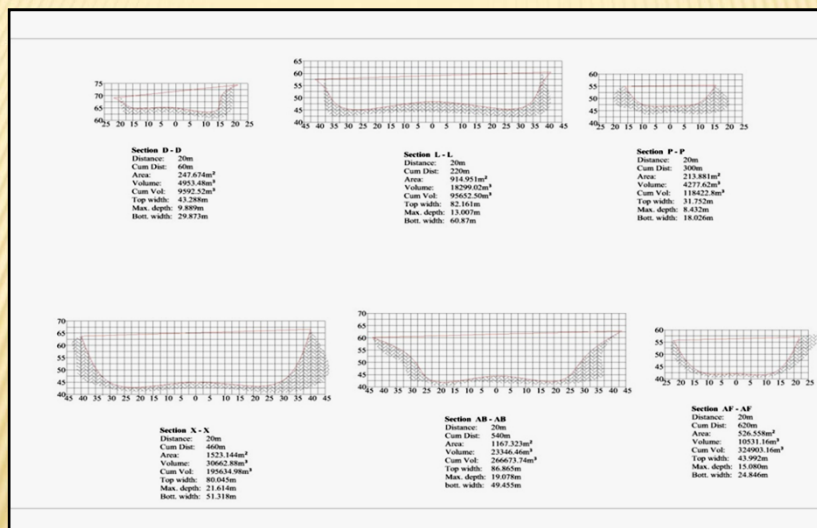
Typical Cross sections of Queen Ede gully

From the cross sections above, it can be seen that the gully is U – shaped, thus; we can conclude:

- The run-off contributing catchment area is large and therefore the discharge passing through the gully is also large
- The longitudinal slope of the gully bottom is parallel to the land slope
- The run off enters the gully from the head and from the sides at points where adjacent land is slightly lower than the surrounding.
- The gully have been formed by under cutting and collapse of the bank walls
- The gully continue to expand towards the head as active erosion action occurs mainly from side walls near the head as a result of under cutting of the base and walls

The cross sectional surveys revealed that the Gully is U shaped which show that the run off contributing catchment area is large and therefore the discharge passing through the gully is also large.
