Parametric Sub Bottom Profiler measurements of the subaquatic portion of the debris fan of Gschlifgraben in Lake Traunsee, Austria

Brian Kreis & Sebastian Riegler (students)
Erwin Heine

BOKU University of Natural Resources and Life Sciences, Vienna

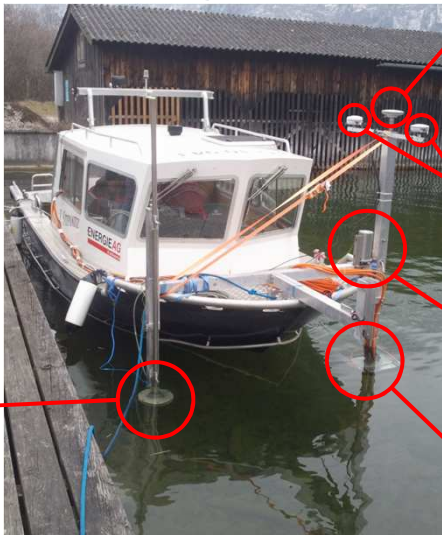
Data acquisition: survey vessel (outside)

- GPS rover
- Additional GPS antennas
- MRU-Z
- EA 400 transducer
- SES-2000 light plus transducer

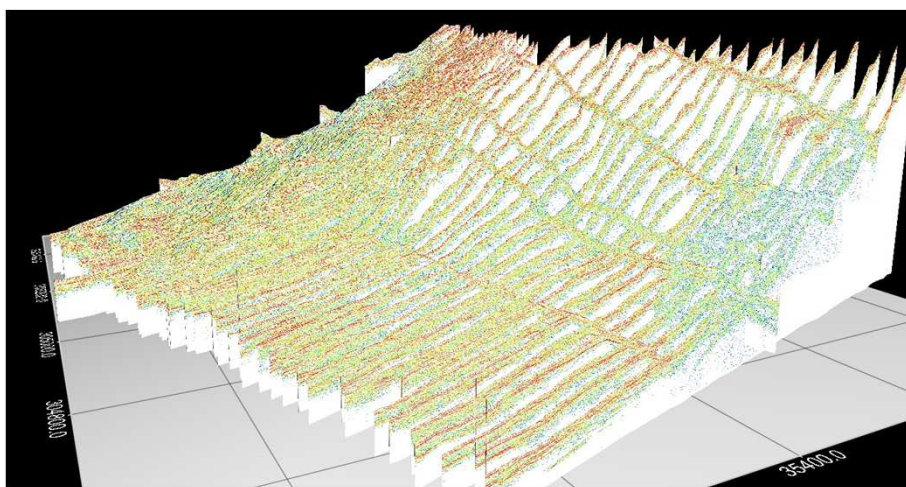
Results (2)

- Identification of **three different zones**:
 - The **upper part** (from water level to ca. 60 m) consisting of **highly reflective material** with a layer thickness of up to 5 m.
 - The **middle part** (from ca. 60 m to ca. 130 m), which is made up of **less reflective material** characterized by morphological distortions in which layers of sediments could be found in basins.
 - The **lower part** with **stratified sediment layers** in which the signal could penetrate the bottom up to 15 m.

- Identification of **three different zones**:
 - The **upper part** (from water level to ca. 60 m) consisting of **highly reflective material** with a layer thickness of up to 5 m.
 - The **middle part** (from ca. 60 m to ca. 130 m), which is made up of **less reflective material** characterized by morphological distortions in which layers of sediments could be found in basins.
 - The **lower part** with **stratified sediment layers** in which the signal could penetrate the bottom up to 15 m.
